AMERICAN SOCIETY OF CIVIL ENGINEERS.

TRANSACTIONS.

(Vol. VII.—September, 1878.)

THE DANGERS THREATENING THE NAVIGATION OF THE MISSISSIPPI RIVER AND THE RECLAMATION OF ITS ALLUVIAL LANDS.

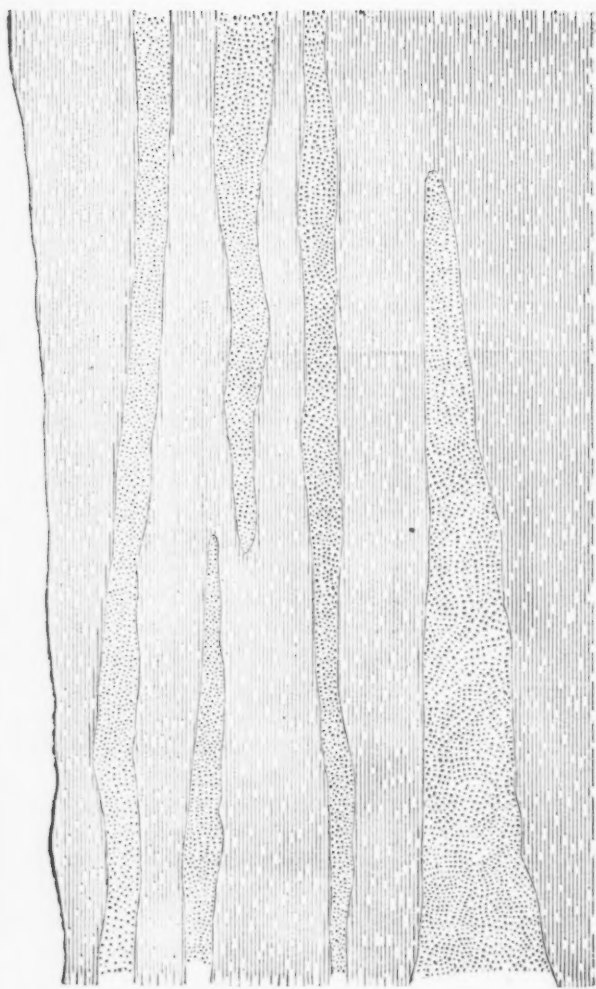
SECTION THROUGH ALLUVIUM.

The caving is immediately produced in two ways—which are characteristic of sand or clay bank. When the changes in the course of the river throw the force of the current against a bank of recent formation by deposit, it wears to a steeper slope than the limited tenacity of the material will maintain. This is the simpler and more rapid process.

When, however, the bank is of older alluvial formation it is found stratified with tough blue clay and flat horizontal pockets of quick-sand, shells or other treacherous material. Whenever one of these pockets is worn into, the contents exude from pressure, or are washed out by abrasion, and the leaf of clay above, deprived of support, breaks off and tumbles its load into the river. The profile of such banks shows the blue clay strata with an easy slope, and those of quick-sand or shells very steep, or even with an overhang.

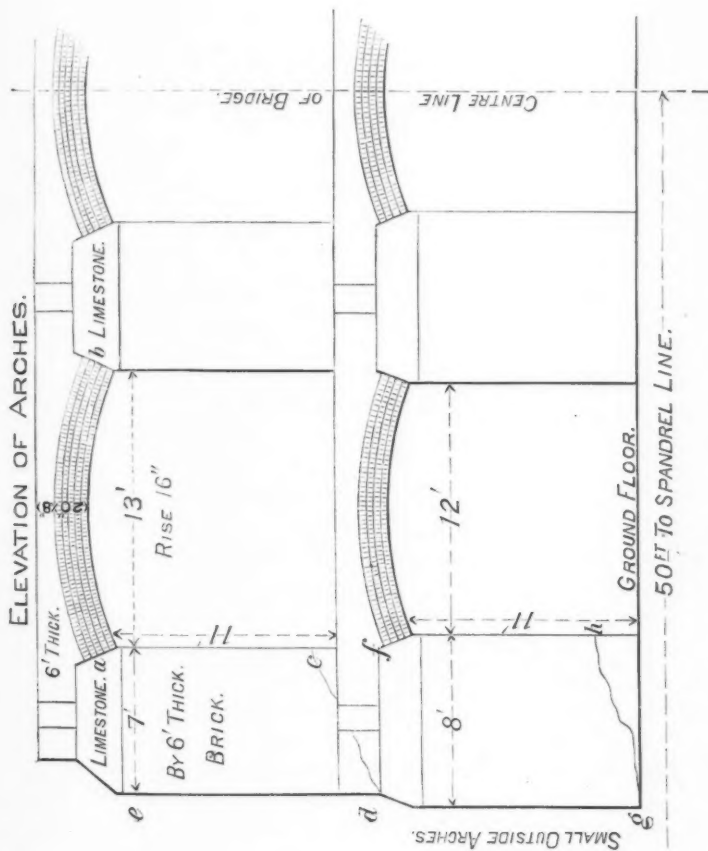
The general arrangement of that work is a series of heavy piers about 100 feet long, and faced with stone, and running across the bridge. These piers are to be connected by heavy arches over which the roadway is to pass. Each pier is to be a double arcade of ten arches, five on each floor. A portion of these are shown in the drawing on page 263, and it was the arch (*a b*) which failed.

The arch had a span of 13 feet; rise, 16 inches, and thickness of 20 inches; and was laid up in five distinct rings of brickwork, or built "rowlock," as it is called. The length of the axis was 6 feet. It abutted on limestone skew-backs, and at the time of the failure about 8 inches of brickwork above the crown had been laid on nearly uniformly. The abutment for 11 feet below the spring was 7 feet wide and 6 feet thick down nearly to the line (*f d*).

At the time of the accident the masons were at work on top of the arch, when the foreman saw a crack open across the top of pier at (*b*). He instantly warned the men and they ran to the ladders. By the time they had descended to the floor below, the end (*b*) had settled about 6 inches, and was turning on (*a*) as a pivot. By the time they reached the ground the arch was falling. It struck the lower arch and broke it in two, and all fell together, leaving the abutment (*g a*) standing, but showing cracks, approximately at (*c d*) and (*g h*), (I have lost the sketch I made at the time). A movement of an inch was probably enough with the crushing of the mortar which would occur, to let the arch slip through.

In other words, he would form masses which would approximate in form to the voussoirs used in stone work, with thinner strongly bonded masses between them.

I ought to say before closing that the exterior arch abutting against this is abundantly strong to take all thrust, and that *this* arch would probably be safe itself when it had the weight of the main arch and roadway upon it.
